Agricultural Ditch Maintenance Workshop

Hedgerow Plantings for Agriculture Ditches

Agricultural Waterway Buffer Study
Whatcom County, Washington
2012

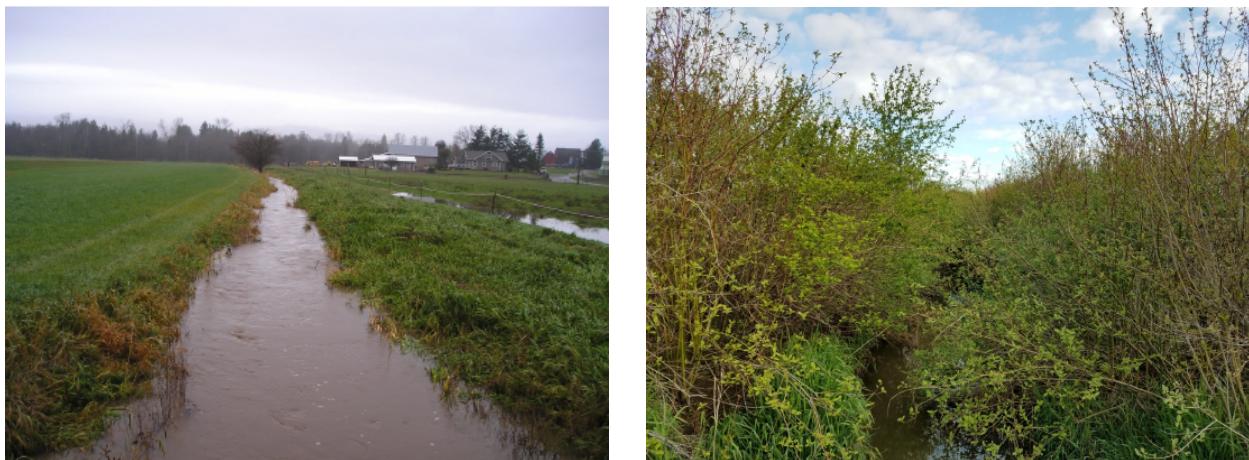
Figure 1: Duffner Ditch, Whatcom County: In 2011 (left) and 2019 (right)

The concept of narrow vegetative buffers along agriculture ditches and waterways has proven successful on the westside. Fast-growing native species, spaced on tight centers, quickly outcompete invasives that clog waterways, provide habitat for pollinators and other wildlife, and effectively filter sediments and pollutants to preserve water quality. Plant species that tolerate mowing are selected to allow for access to a buffered waterway if needed. Ninebark, twinberry, and red osier dogwood perform especially well. Willow is also effective but can be too aggressive and clog the waterway.

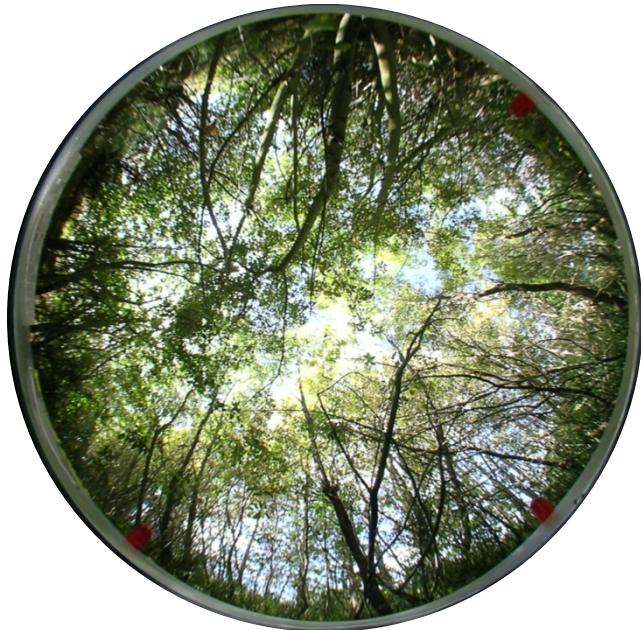
Appendix 22. Sample hemispherical Photo from 35' buffer, calculated effective shade of 76%.

Effective shade was calculated by analyzing hemispherical photographs using HemiView[®] software. Photographs were taken on two dates in September and results are included in [Table 8](#). Values were combined across dates. The no (0') buffer had the lowest effective shade percentages ranging from 3-22%. The remaining buffers all had effective shade percentages above 72% and ranked in numerical order (mean percentage): 76% (35' buffer), 80% (180 buffer), 87% (5' buffer), and 88% (15' buffer). Box and whiskers plots (mean, quartiles, and min/max) are included in the appendix ([Appendix 21](#)). Examples of hemispherical photos can be found in [Appendix 22-26](#).

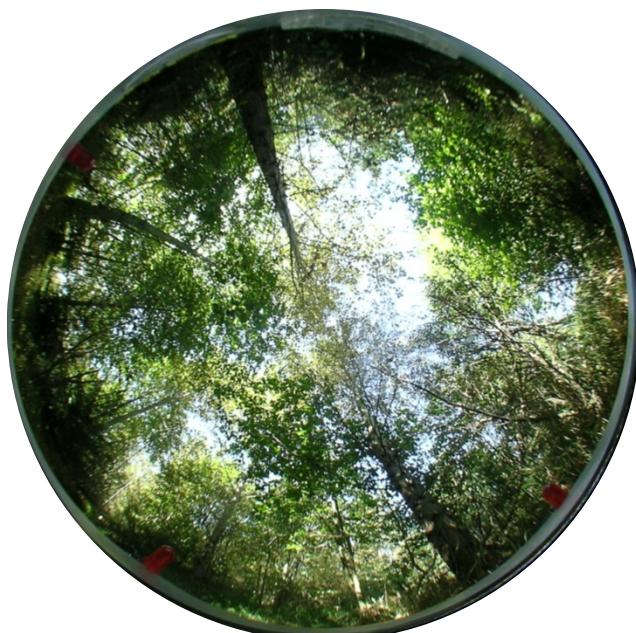
Appendix 23. Sample hemispherical Photo from 180' buffer, calculated effective shade of 79%.

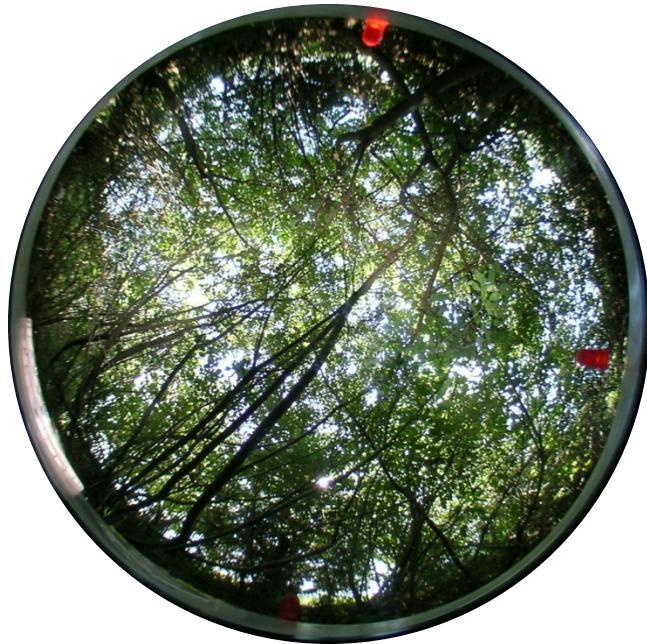
Appendix 24. Sample hemispherical Photo from 15' buffer, calculated effective shade of 89%.

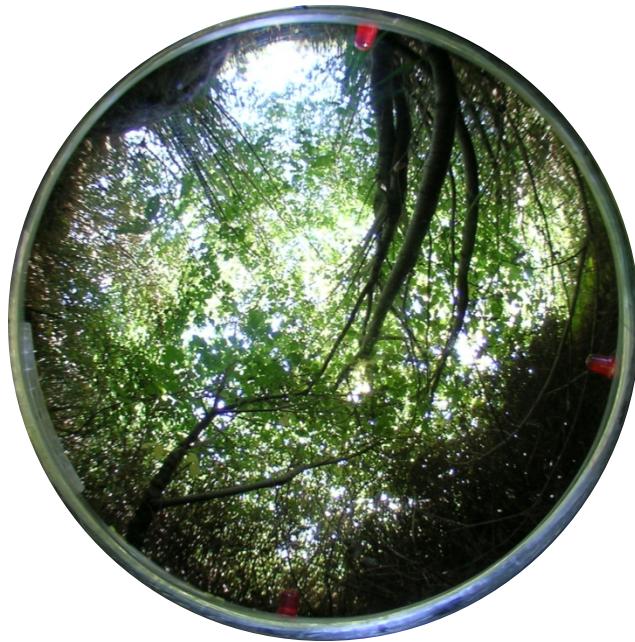
Appendix 25. Sample hemispherical Photo from 5' buffer, calculated effective shade of 90%.

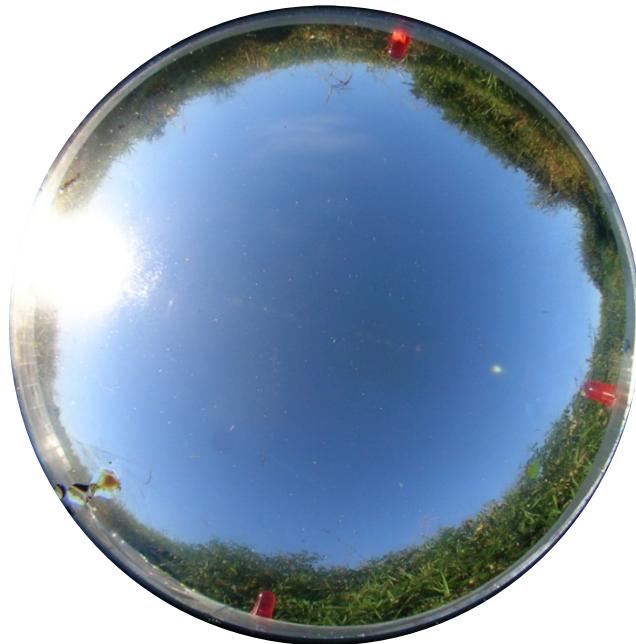
Appendix 26. Sample hemispherical Photo from 0' buffer, calculated effective shade of 3%.

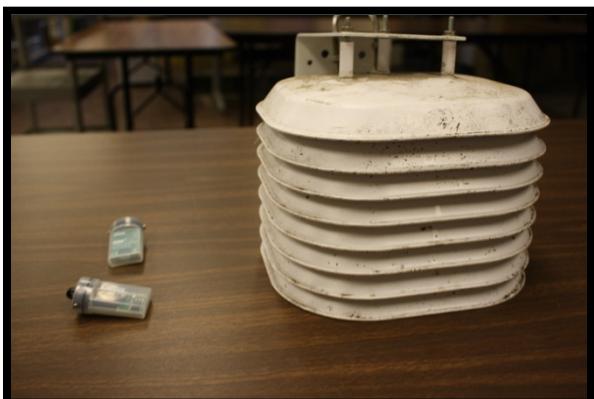
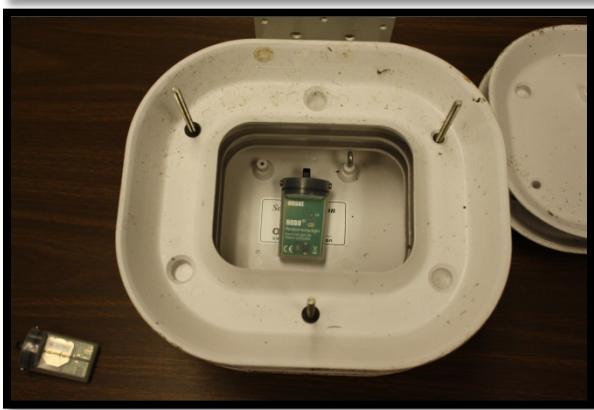
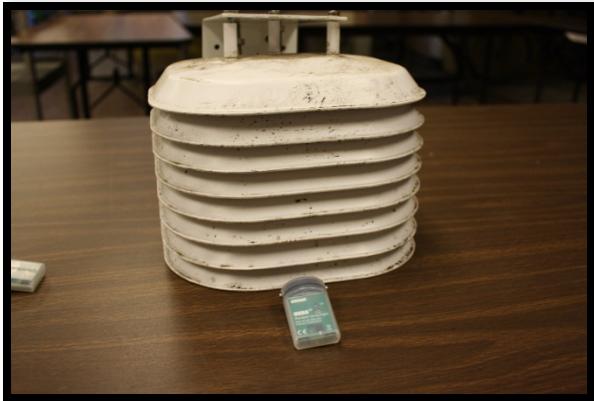
Appendix 27. Photographs of sensor and sensor housing.

Pendant ([Onset® Computer Corporation, Pocasset, MA](#)) temperature logger suspended within a solar radiation shield ([Appendix 27](#)). The stations were staked into the ground on posts three feet above the ground. For each transect; one logging station was placed outside the buffer in an un-shaded area, a second was placed mid-way between the furthest edge of the buffer and the center of the channel, and a third was suspended over the water channel. Data was recorded in 5-minute intervals, uploaded from the data loggers at 30-day intervals, and checked for battery longevity once a month. To evaluate the impact of buffer width on air temperature, data from sensors was compared between (sensor) location within a given buffer width across the replications (5' buffer: outside vs. mid-way vs. overwater). Daily maximum, minimum, and average temperature was calculated and then compared using PROC GLM (SAS, 2002) within each buffer but across sensor location. Before applying the model exploratory data analysis tools were used to describe data variability (e.g. portray data to identify outliers, extreme values, mode, correlation, and test for normal distribution and equal variance).
